This TSB was issued by Tech-2- Tech which is not affiliated with American Honda or Honda Motor Co

## **Shuttering / Quivering on Acceleration / Failing EGR Function Test or NOx Test**

## 1990-1993 Accord L-4 Engine EGR Port Cleaning Procedure

## 1994 and Up Accord L-4 Engine EGR Port Cleaning Procedure

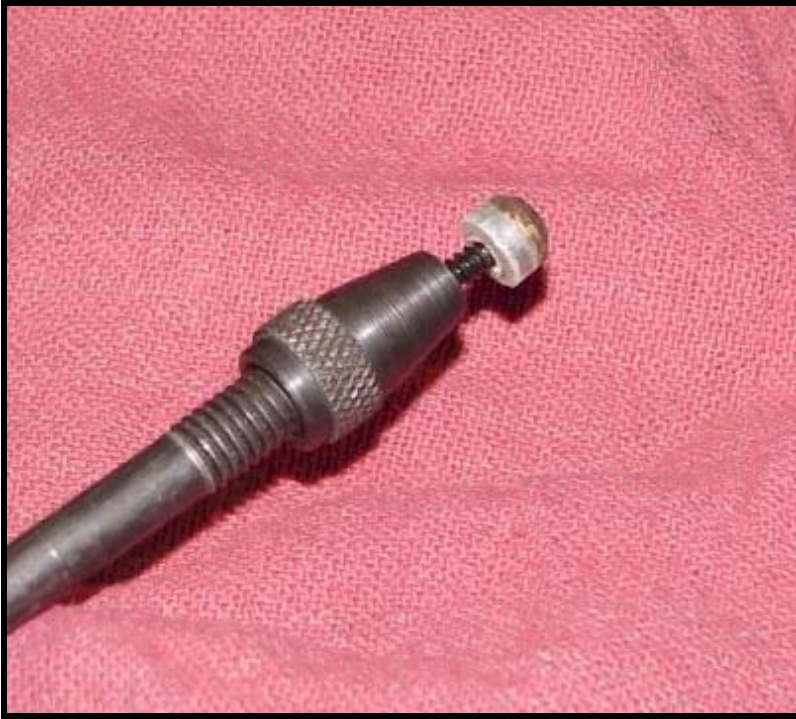
A picture of an EGR passage port still attached to the slide hammer.

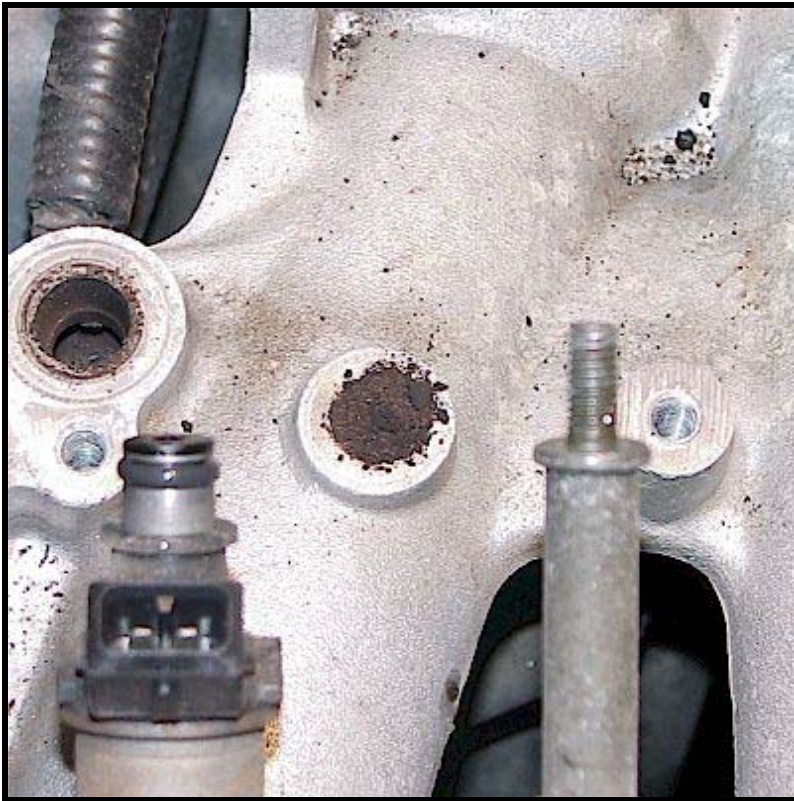
Here is a close-up shot of a clogged EGR port.

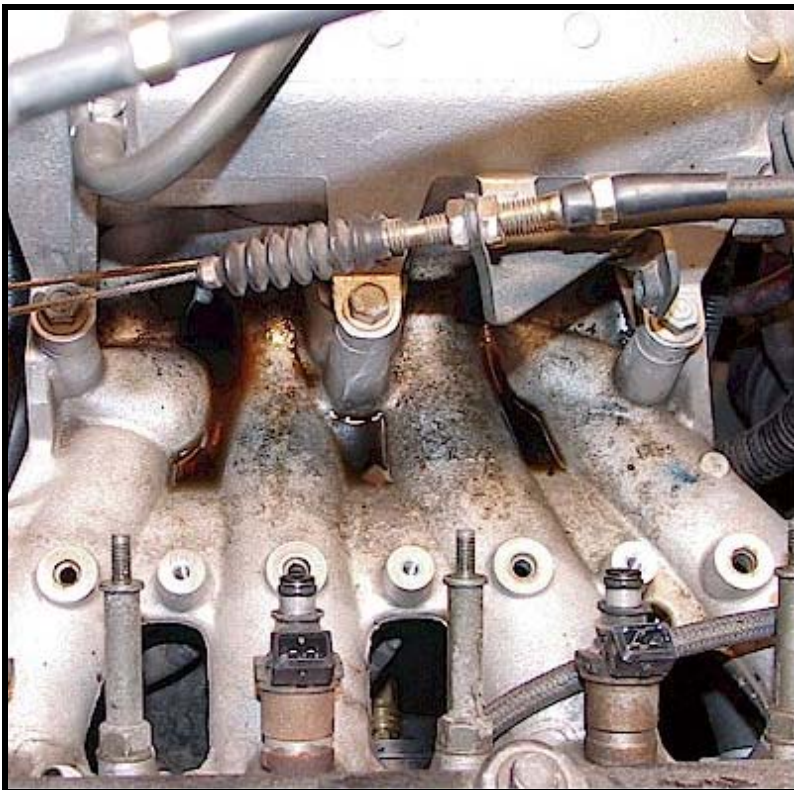
Here is a picture of all 4 ports cleaned up and ready for re-assembly. Cleaning is best done with a pick and then a bottle type wire brush.
